Pilot Application of the Guidelines on improved water allocation Al Fara'a Watershed as a case study

Prepared by Palestinian Team
September, 2022

Al Fara'a Watershed as a case study

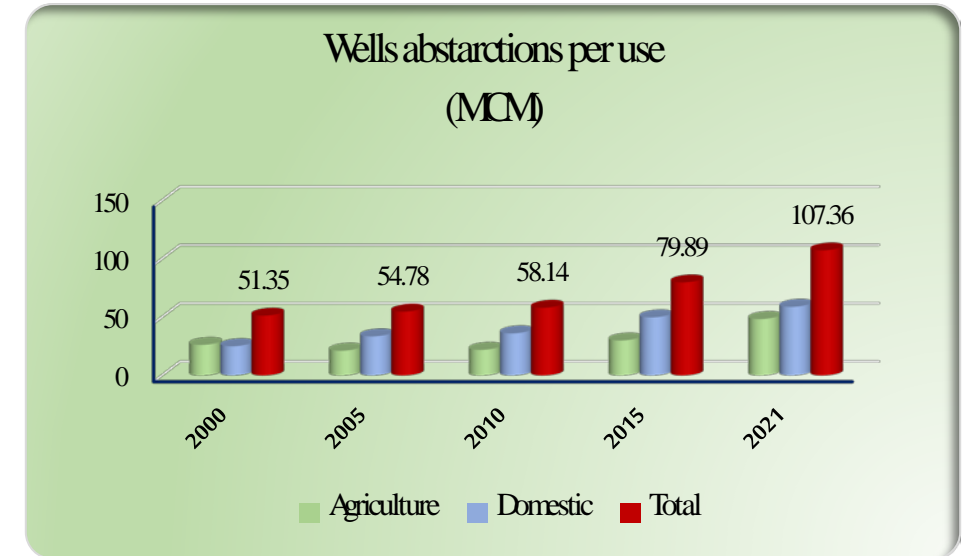
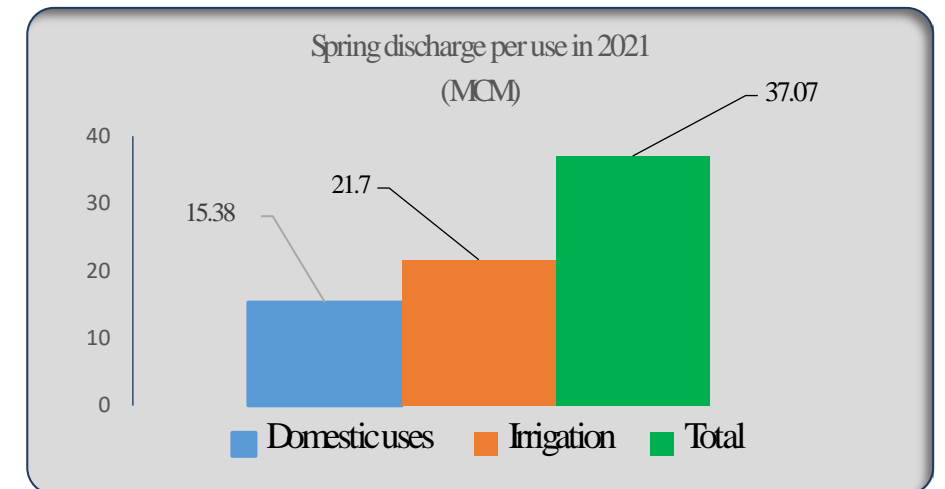
Water uses in the West Bank (2021)

The average amount of water consumed in Palestine - the West Bank and Gaza Strip - is about 448.4 million cubic meters annually

233 million cubic meters are used in the West Bank (151.56 MCM for drinking and industrial purposes and 81.67 MCM for irrigation and agriculture)

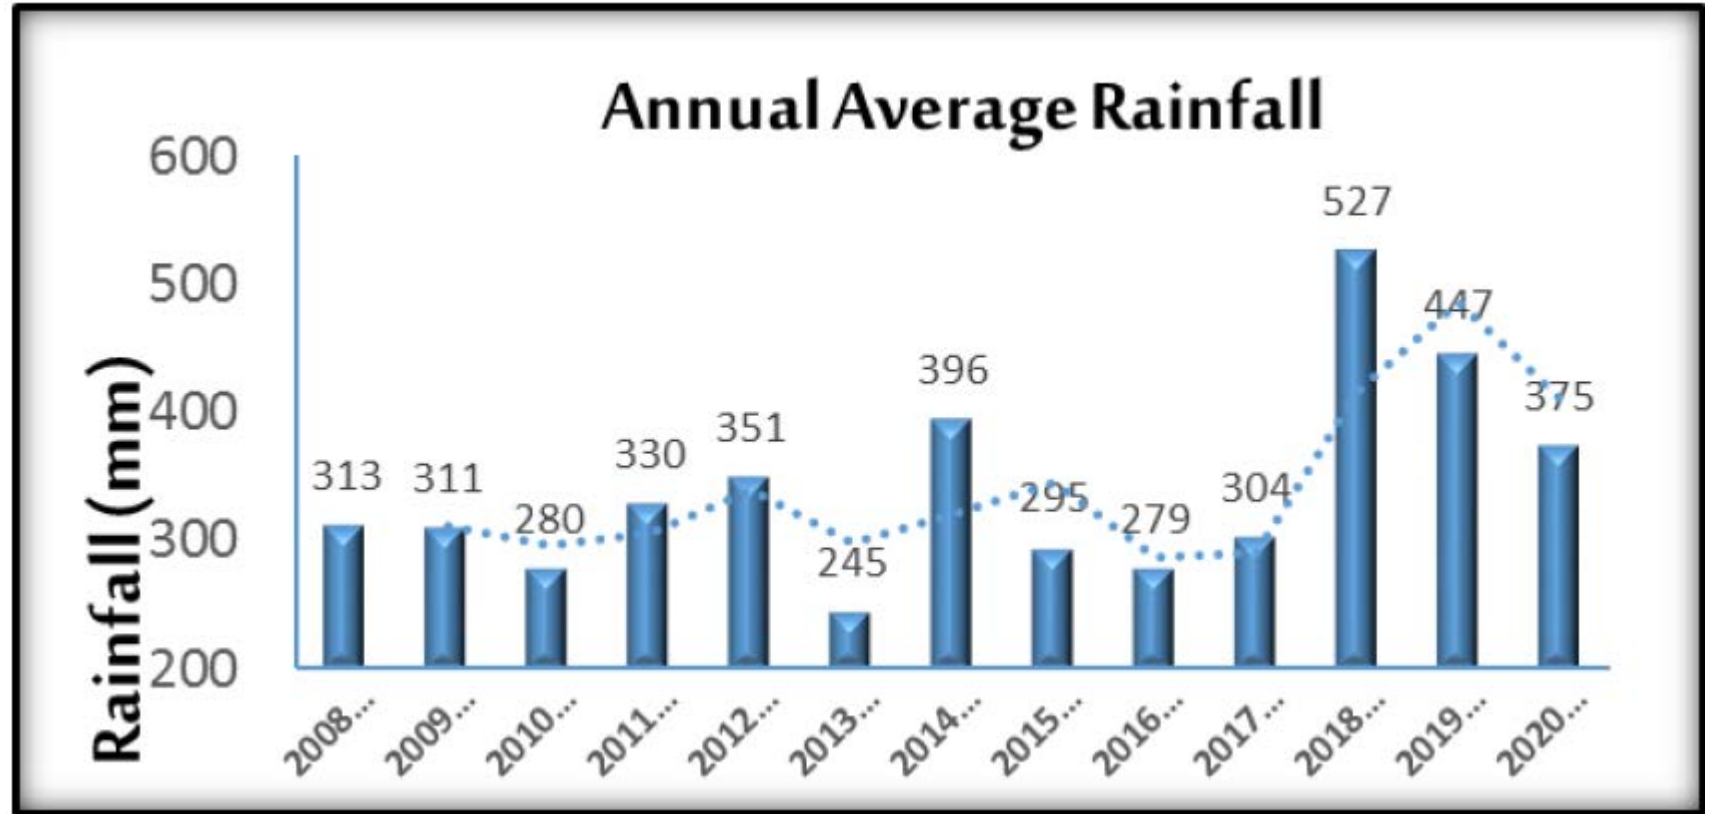
Rainfall data Analysis

Recharge is highly dependent on rainfall quantity, intensity and distribution

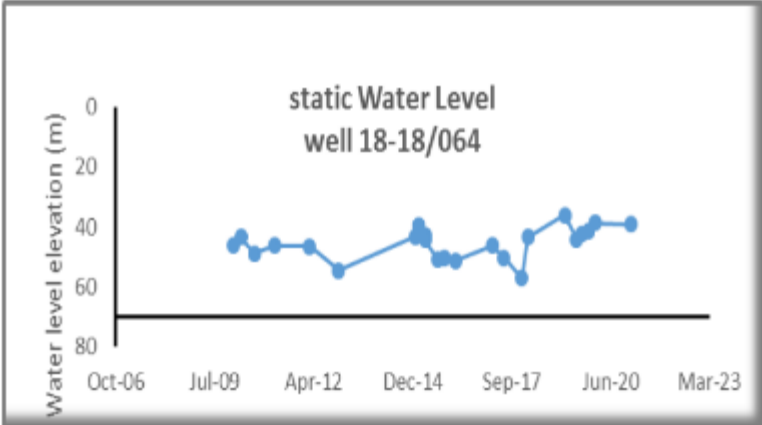
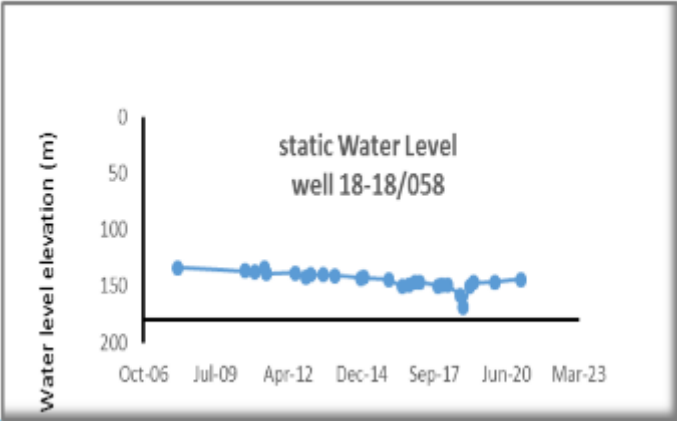
Stable and/or not changing significantly in the upstream

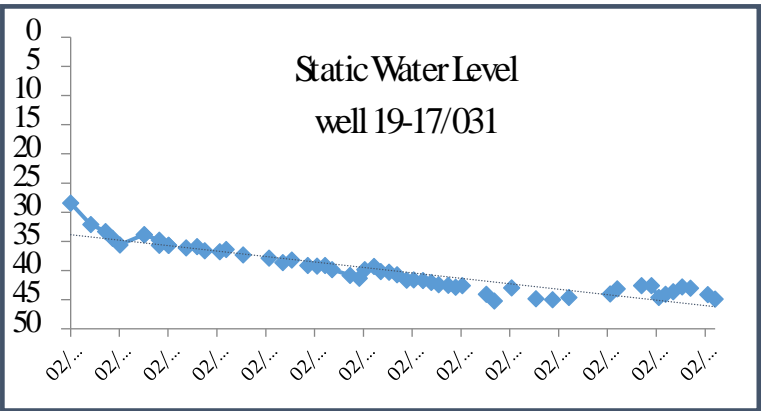
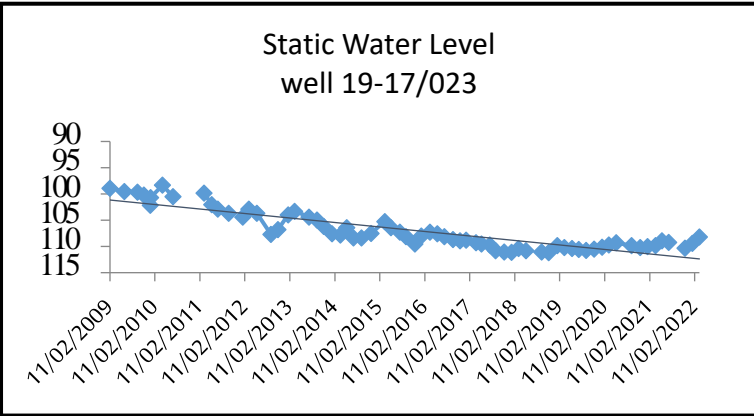
Declining in the downstream mainly in Al Jiftlik Area

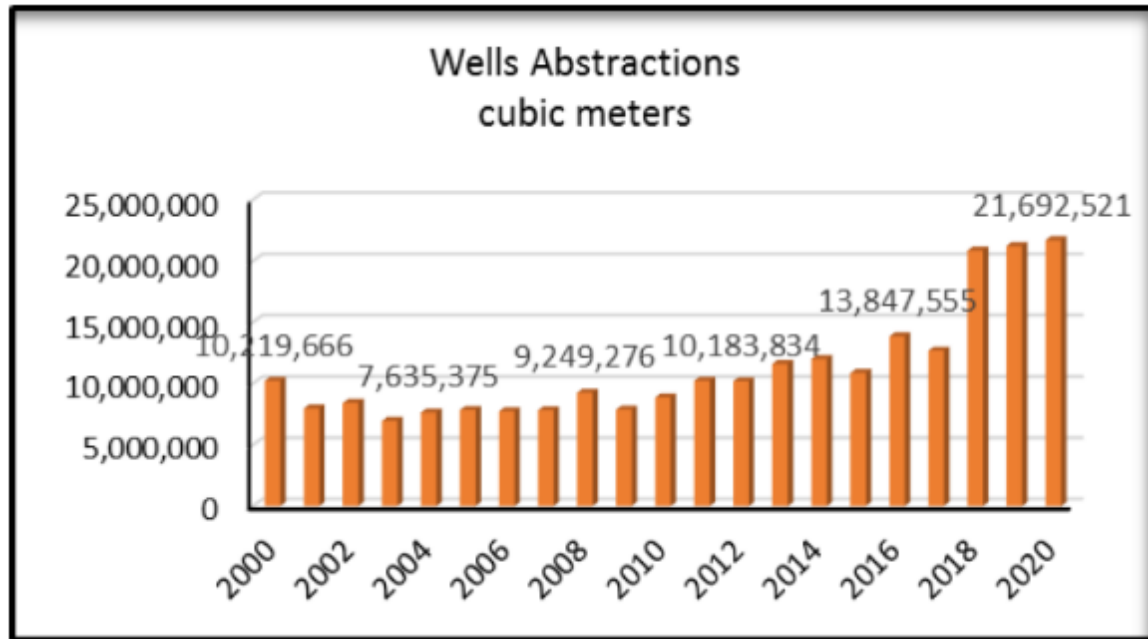
Increased trend in pumping from wells in general

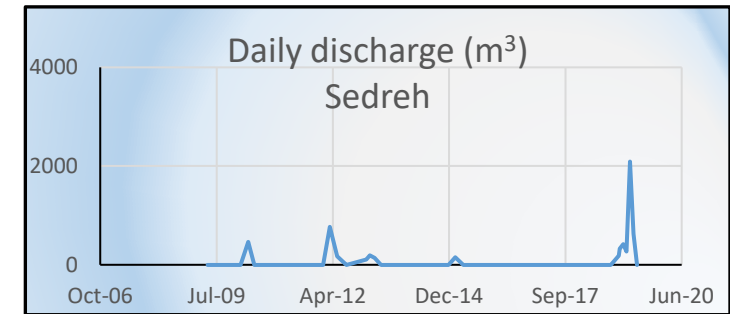
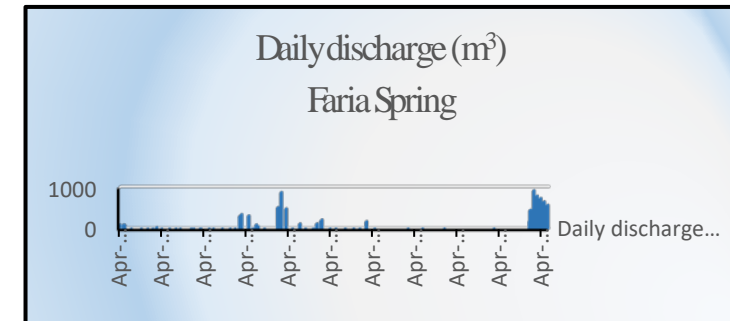
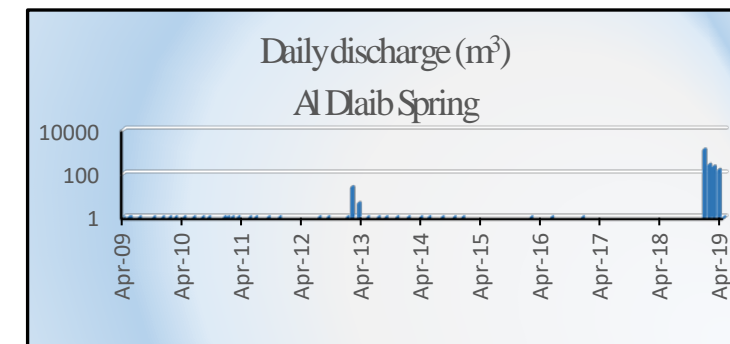
Some of the springs dried continues to discharge after 2017, this is due to decrease in well pumping in Sahl Smeit
